# Appendix A

New Mosquito Control/Rodent Control Building

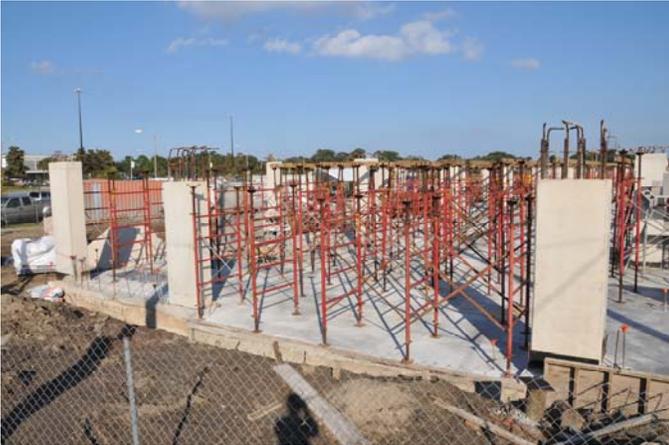
Figure 45. Columns were poured on 11/19/2011.

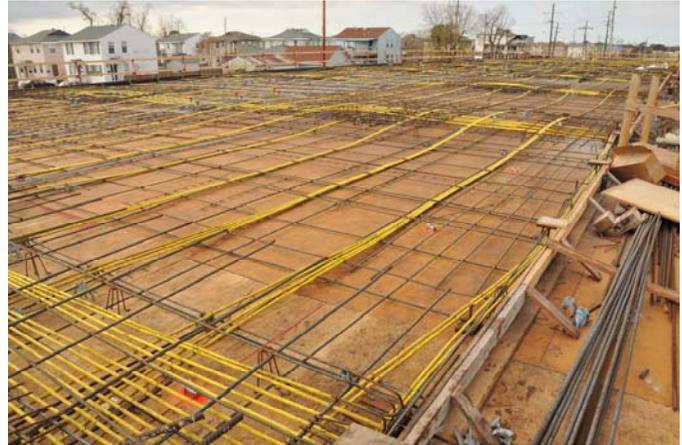
Figure 46. The cables were visible for pre-tensioning the slab for the second floor on 12/9/2010

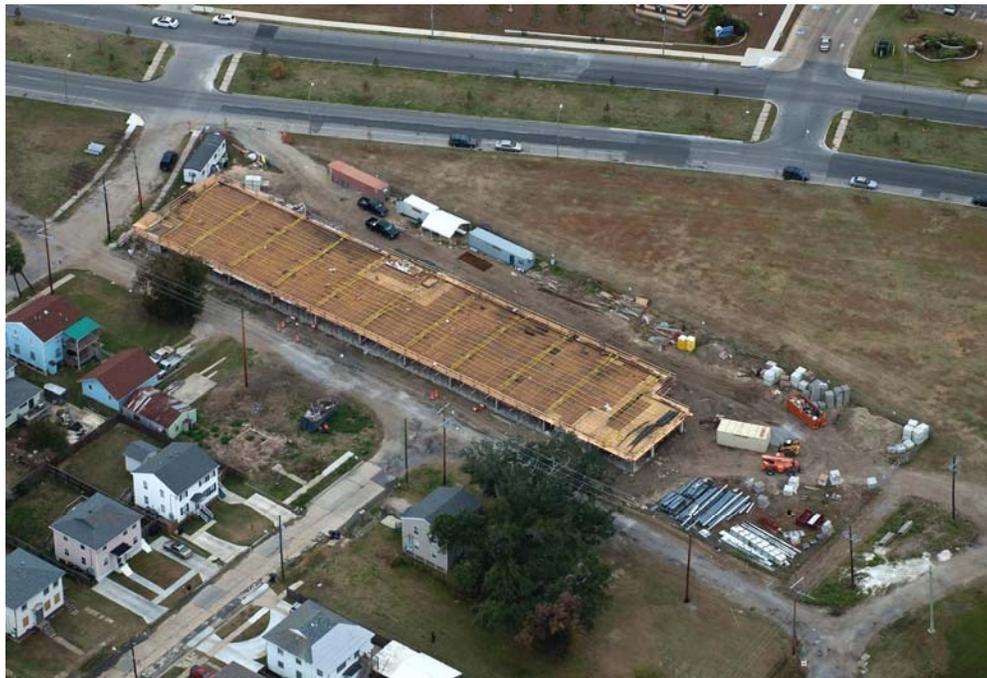
Image # 101215 2004  
Date 12.15.10

Figure 47. Second floor was framed to prepare for the pouring of the second floor.
