CITY OF NEW ORLEANS

Vieux Carré Commission

Guidelines for Exterior Maintenance

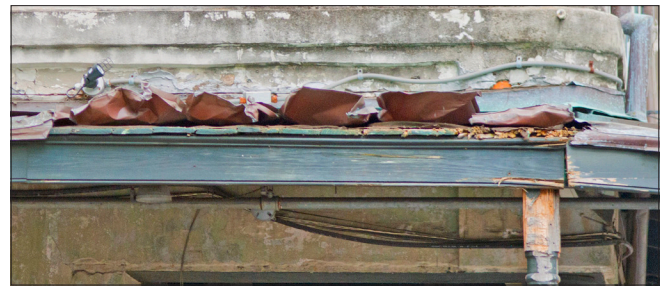
The edge of the roofing at this gallery is bent and not secure. A strong storm winds could peel the roof off of the building.

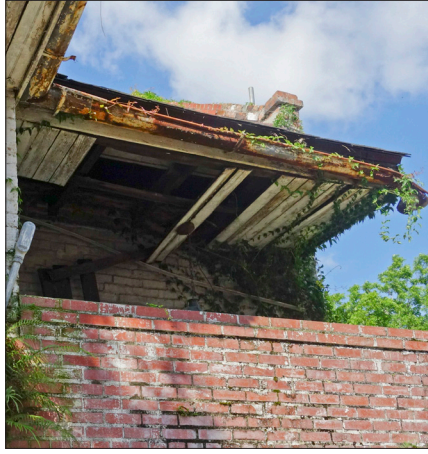
Damage caused by moisture infiltration is evident along the roof overhang. The gutter is dislodged, several soffit boards are missing and/or displaced, and vine growth is progressing on and between the building's components.

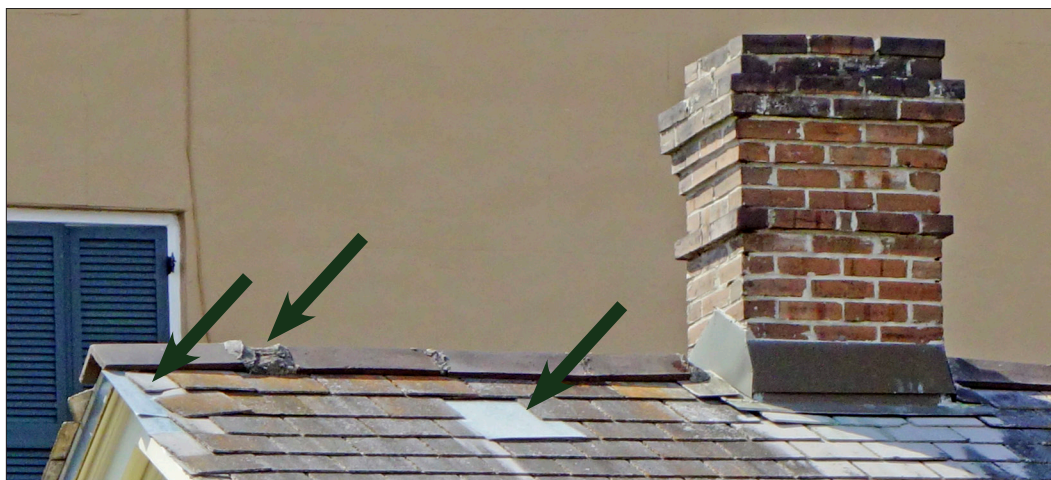
Prior patching is evident in multiple roof locations. Note the poorly executed expanded ridge joint repair of the ridge tile.

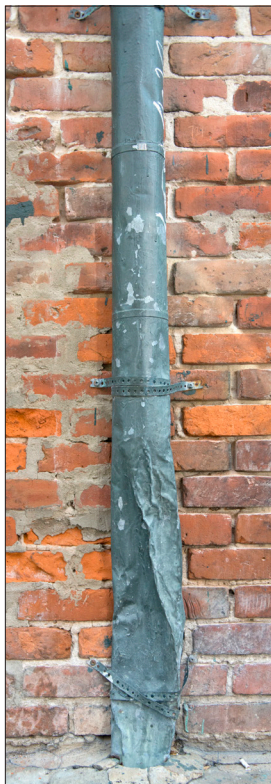
The crushed downspout is impeding water flow.

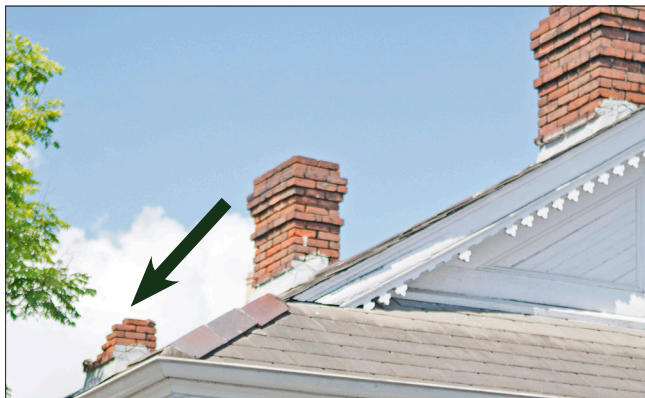
The rear chimney has collapsed and there is significant mortar loss at the remaining two chimneys.

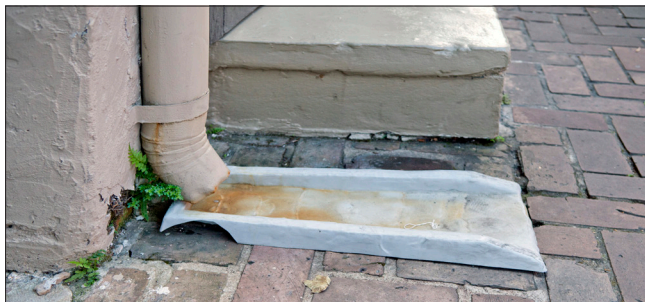
A splash block can direct storm water from a downspout away from a building.

<ul style="list-style-type: none"> Cast iron downspout boot is rusted 	<ul style="list-style-type: none"> □ Remove rust to bare metal – Apply rust-inhibitive primer and paint
	<ul style="list-style-type: none"> Water is pooling adjacent to foundation 	<ul style="list-style-type: none"> □ Re-grade area at foundation to direct water away from building □ Verify water exiting downspout is directed away from building foundation - Install splash block or downspout extension at base of downspout to direct water to drain (see example below)

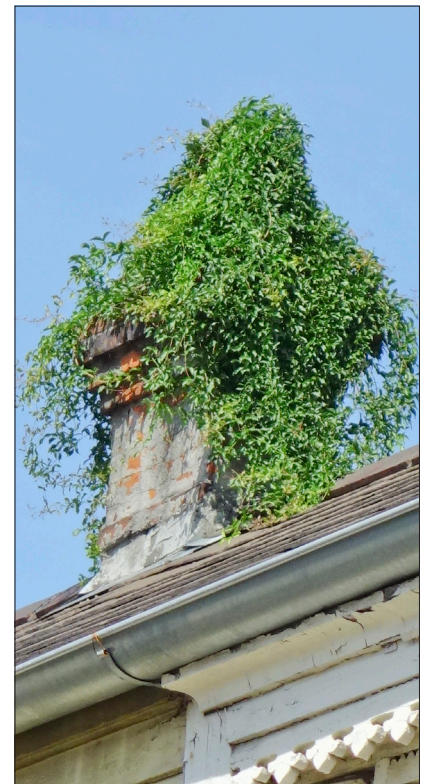
The vines on the chimney may clog the flue and dislodge the mortar.

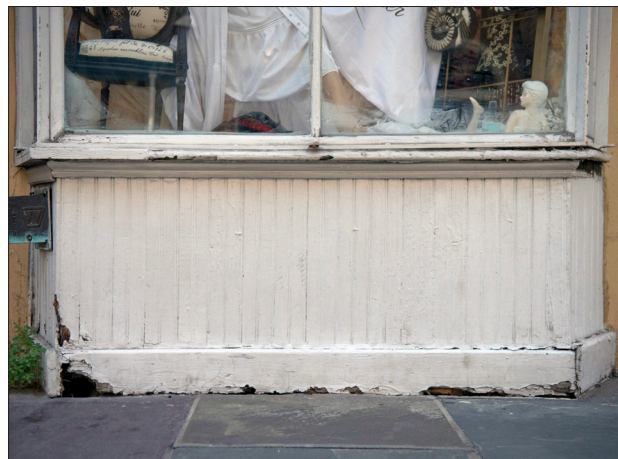
Wood in contact with the ground is more susceptible to damage from storm water, termites and fungi, requiring more frequent maintenance. The larger opening can also allow rodents and pests to nest under the display window.

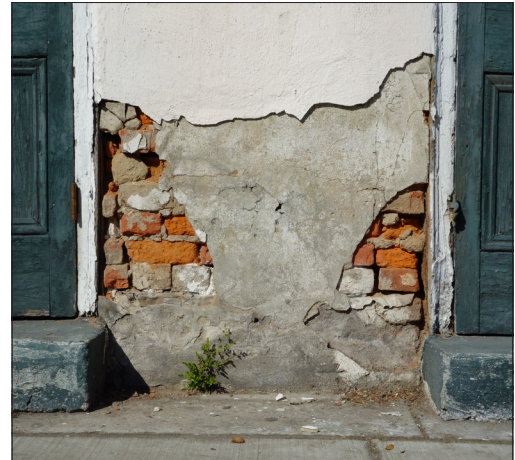
The cracked and missing stucco reveals loss of mortar as well as brick damaged from water infiltration.

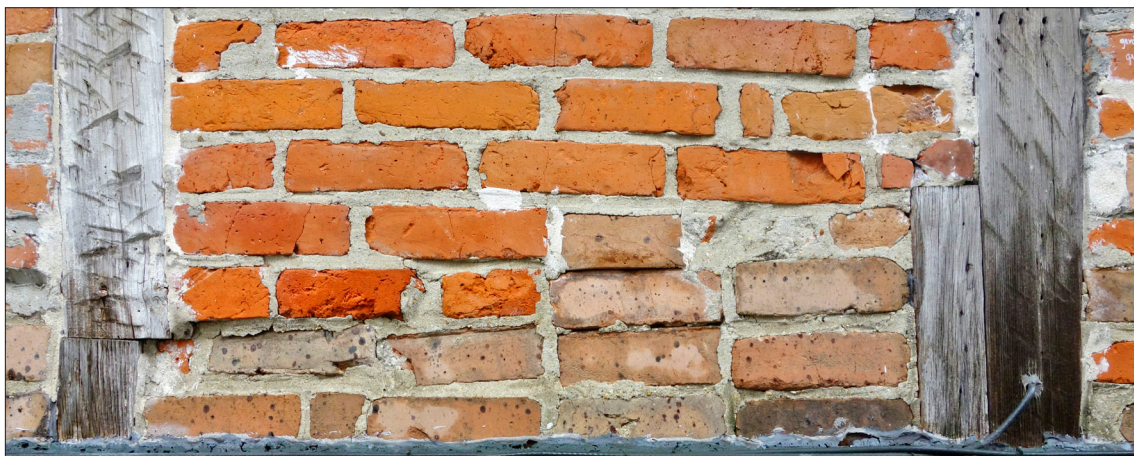
This brick-between-posts exterior wall, now exposed to the elements, was designed to be protected with a coating of stucco. Without this layer, the soft brick substrate quickly deteriorates. Wood repairs and replacement bricks are evident.

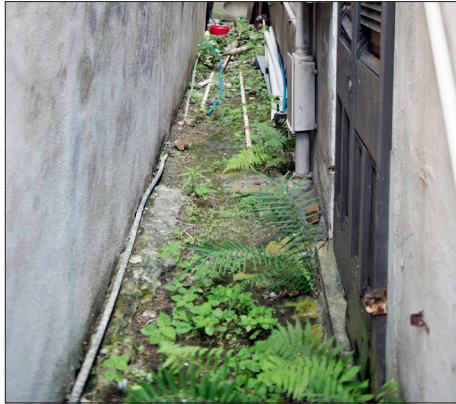
The area around a building should be cleared of debris and weeds to allow clear flow of storm water. Plant growth should be minimized to prevent roots from taking hold in the foundation of a building or wall.

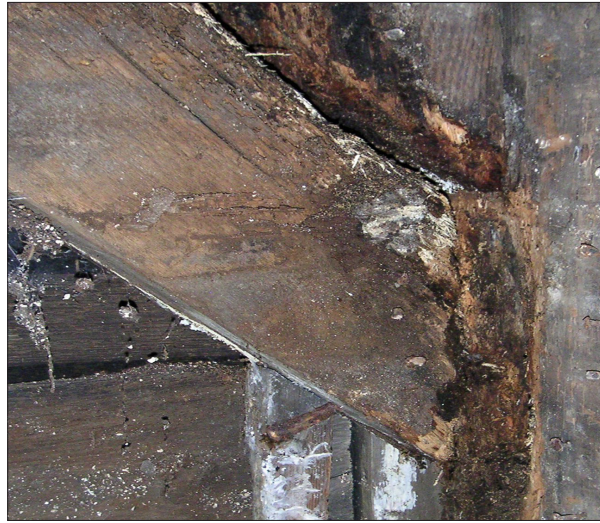
The dark areas at the top and side of the diagonal wood brace indicate moisture issues. The end of the diagonal wood framing is rotting. The cause of the moisture infiltration should be addressed and the wood framing repaired.

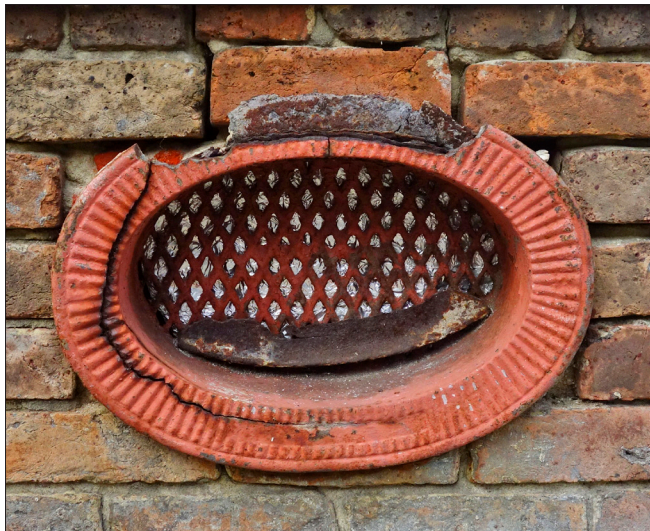
The foundation vent is cracked and rusting. The grille has been blocked from behind reducing air circulation in the crawlspace. Also note the loss of mortar at the brick joints.

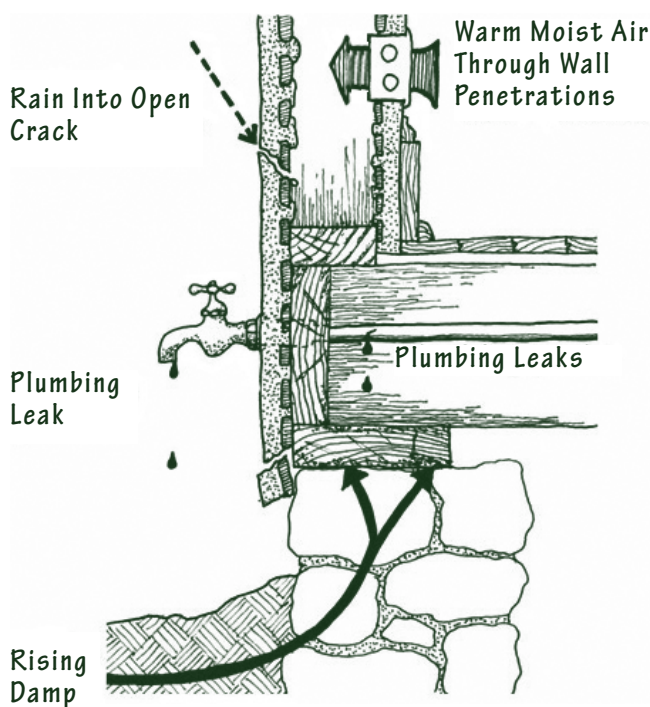
Condensation occurs when warm moist air from a kitchen, bathroom or laundry facility comes in contact with a cold surface and changes to water droplets.

Plumbing Leak can occur from a leaking bathroom fixture, kitchen or laundry appliance, as well as from interior or underground piping.

Rain and Precipitation can enter the exterior envelope through a damaged or cracked surface or a joint between adjacent materials such as at a window or door frames.

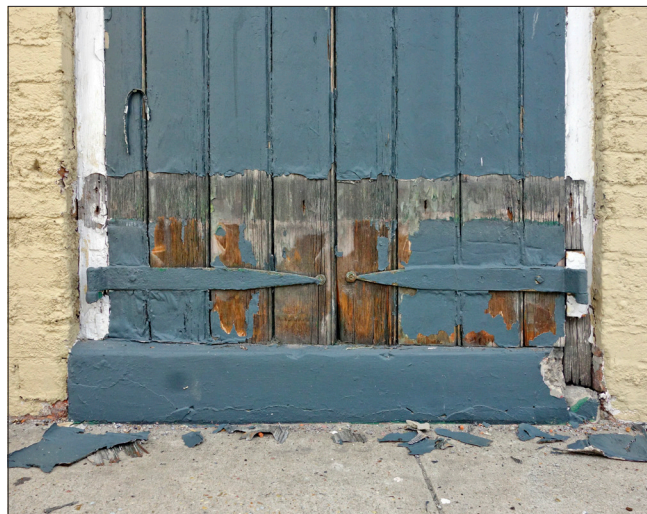
Improperly maintained paint along the bottom of the shutters leaves them susceptible to damage from moisture, termites and other pests.

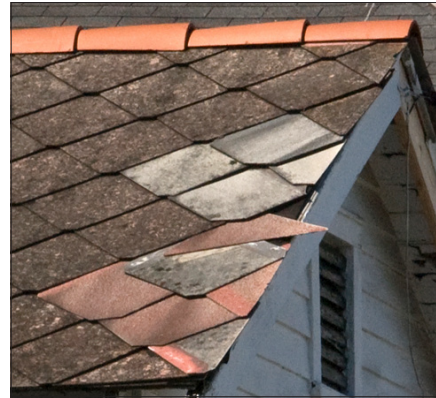
These asbestos shingles are wearing and cracking. Prior patching is evident. Removal and proper disposal should be completed by a licensed contractor as part of roof replacement.
