CITY OF NEW ORLEANS

Vieux Carré Commission

Guidelines for Roofing

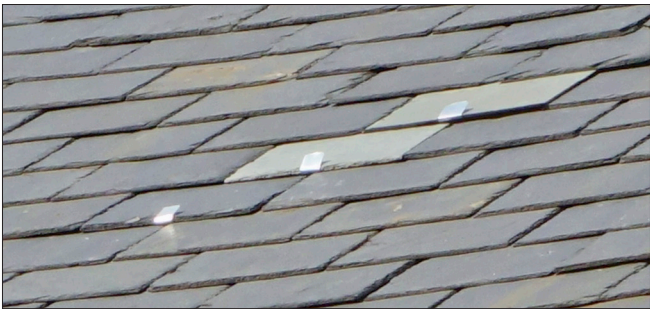
Metal hangers often are used to secure dislodged slates or replace individual slates.

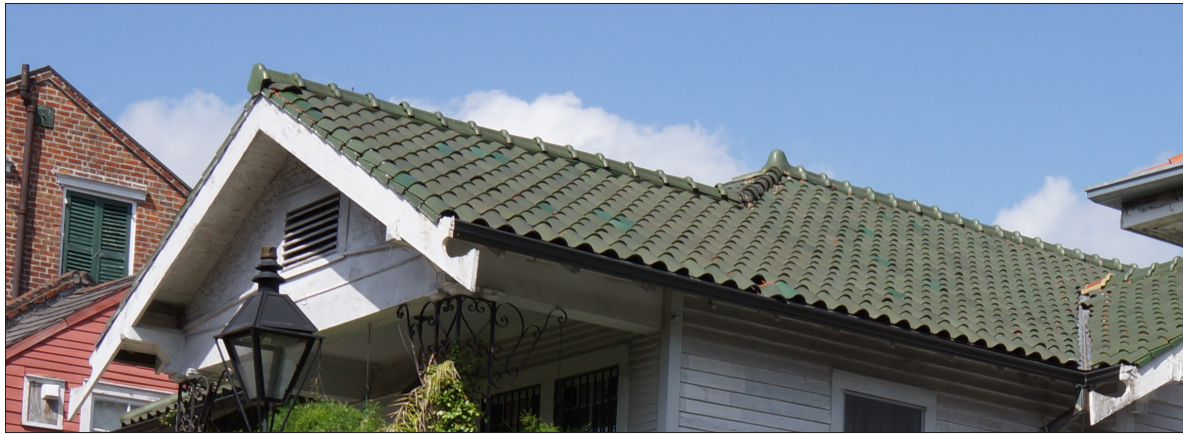
The terra cotta at this roof includes a green glaze. Also note that specialty shapes are used along the ridge cap and hips, and exposed metal flashing is located in the valley.

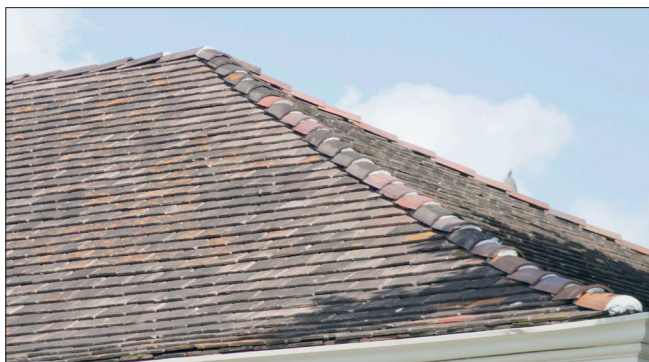
Historically, terra cotta tiles were available in a variety of shapes, including plain rectangular tiles, as shown above, similar in form to slate.

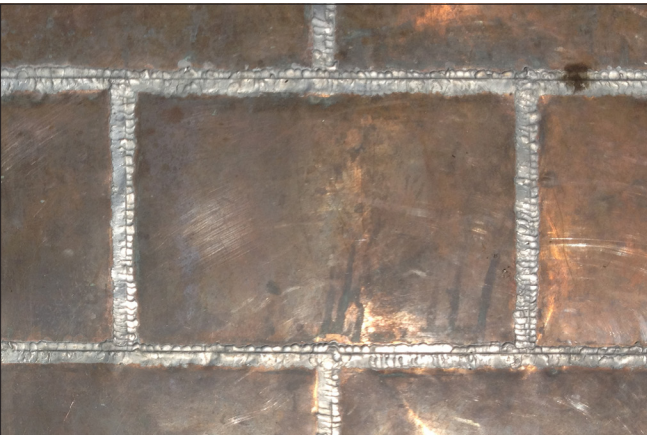
For a low-sloped or flat roof, copper sheets can be soldered together for a weather-tight surface.

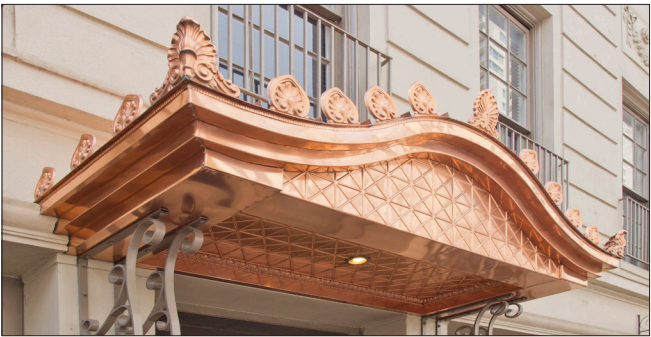
Sheet metal such as copper may be formed in a variety of shapes with different patterns. This entrance hood will naturally acquire a patina, turning green over time.

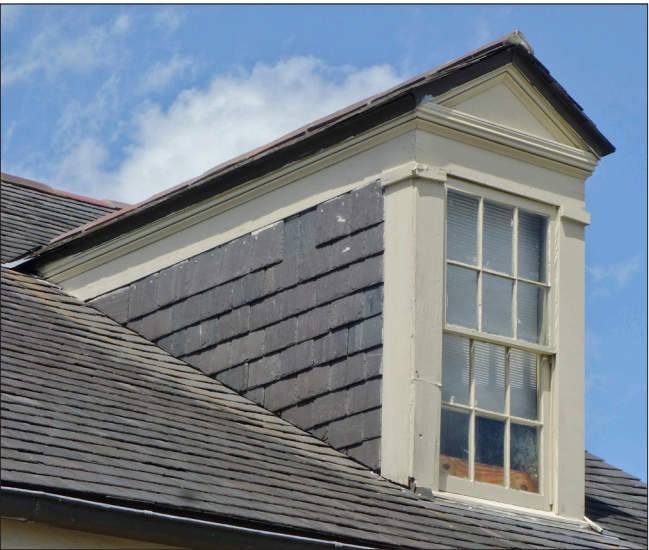
This dormer has a defined pediment, a triangular gable end, reminiscent of classical detailing. One slate is missing at the cheek wall, or side wall, and should be replaced.

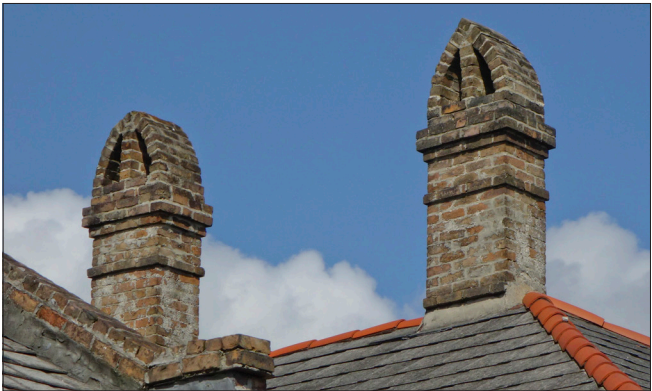
These chimneys have "Bishop Cap" tops formed with bricks.

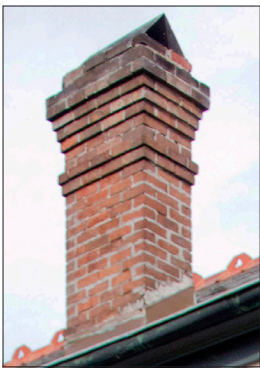
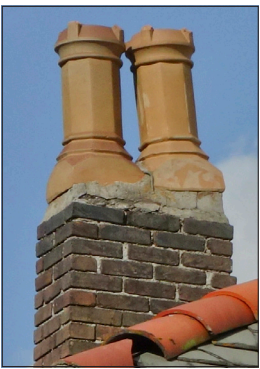
Chimney with "V" cap (left), and terra cotta chimney pots (right).

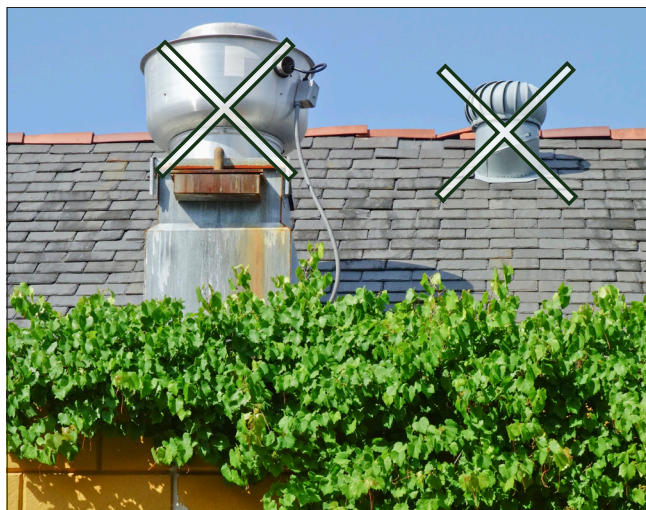
The restaurant vent (left) is located within the building envelope; however, it is visually prominent and, therefore, not appropriate. The turbine ventilator (right) is also not appropriate in the Vieux Carré.

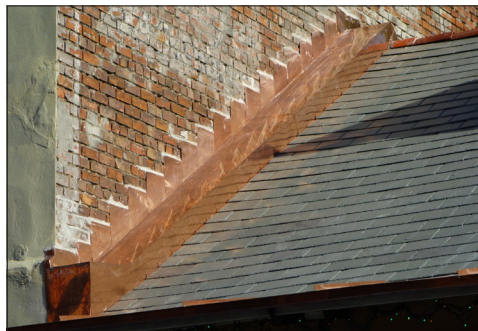
Newly installed, stepped copper flashing is located along the juncture of the parapet with the adjacent wall.

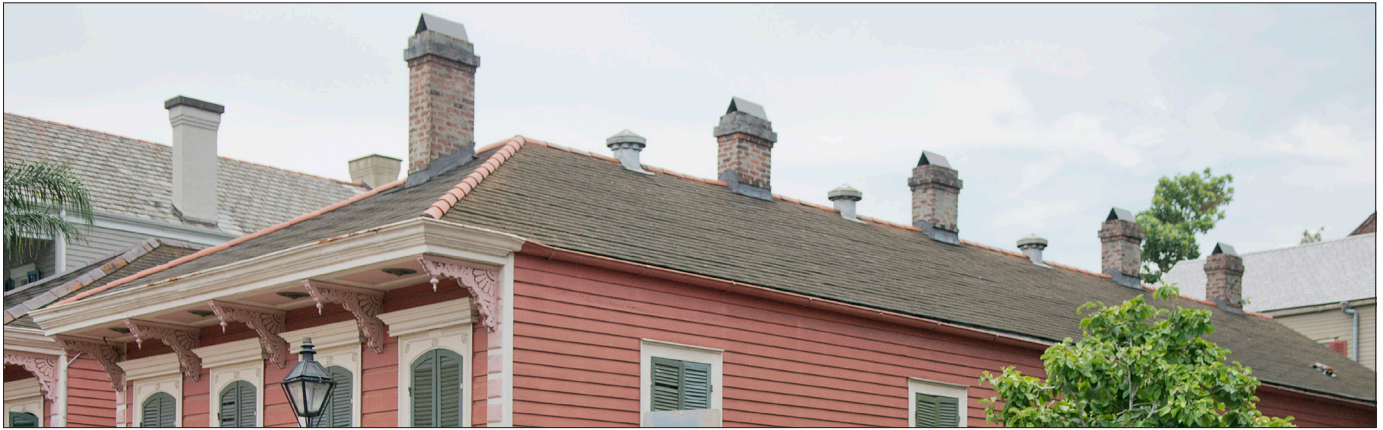
Terra cotta ridge caps are located along the roof hips and top ridge. The five chimneys are topped by inverted “V” caps. Their placement reflects the historic internal organization of rooms within the residence. Also note the Chinese cap roof vents, which help to cool the attic in warm weather.

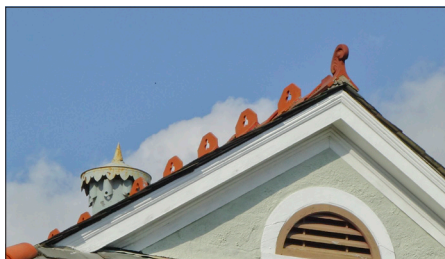
Decorative cresting and finials are often made from terra cotta. A Chinese cap and louvered vent provide attic ventilation.

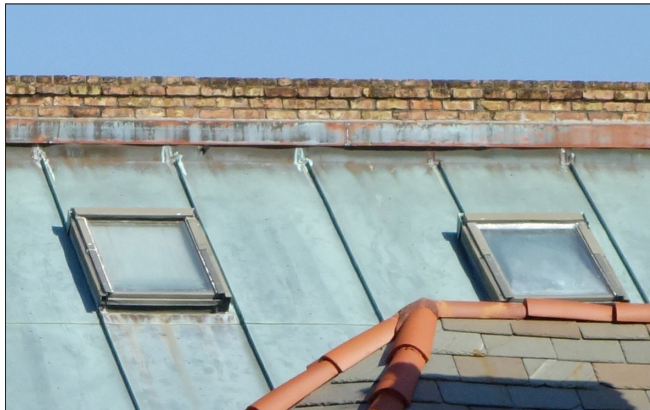
These skylights have a low profile and are located at least 12-inches below the top of this standing seam copper roof.

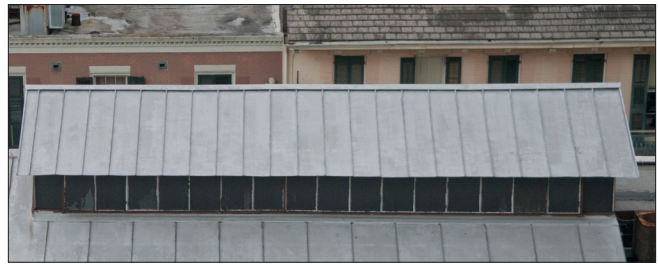
This roof monitor is located along the roof ridge and includes a continuous row of windows.

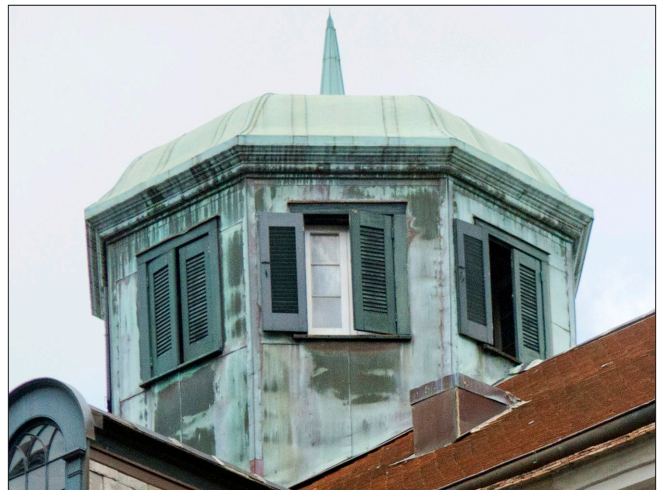
While a roof monitor is generally rectangular and located along the roof ridge, a cupola tends to be round, square or octagonal, as in this example.

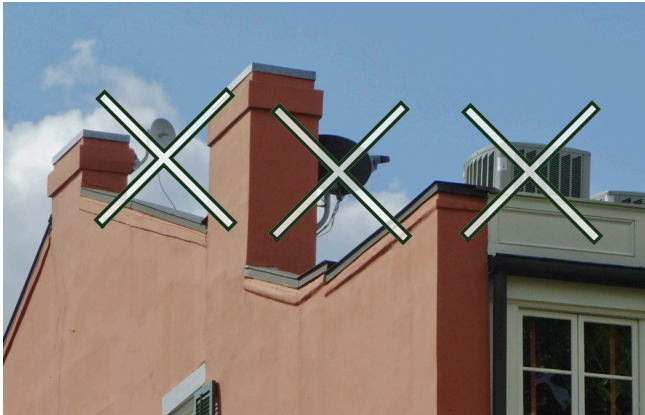
This roof includes a visible air compressor unit and two television dishes. Roof mounted equipment should be located to minimize visibility from all locations.

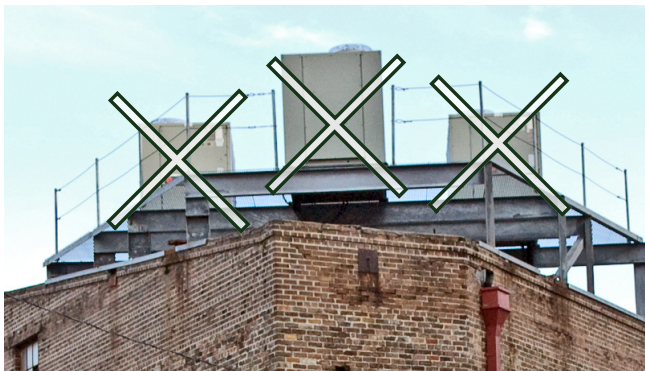
The visibility of mechanical equipment should be minimized and located to least disrupt the appearance of the historic building, streetscape and District.

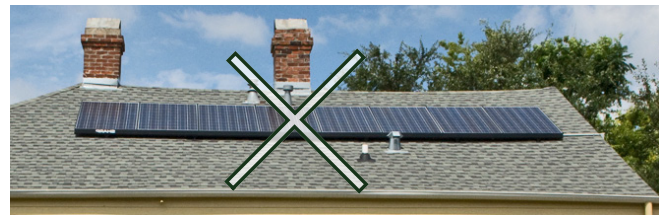
This solar collector is highly reflective making it more noticeable and visually dominant on the roof surface.

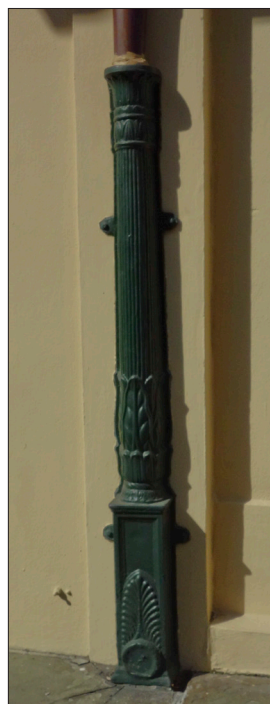
A decorative cast iron boot should be retained.
