# CITY OF NEW ORLEANS

## Historic District Landmarks Commission

### Guidelines for Roofing

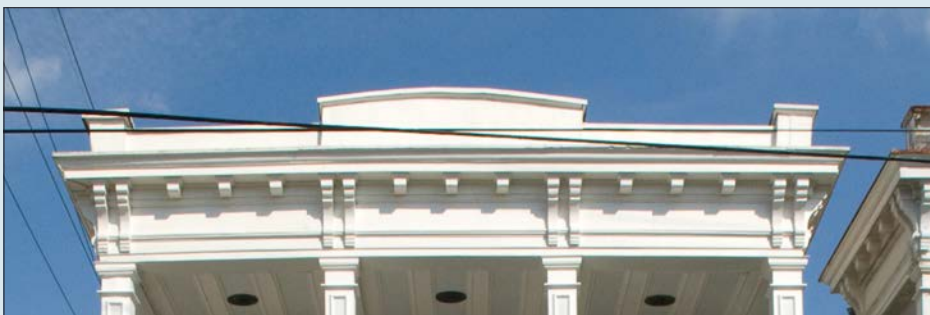
*The parapet on this residential gallery features a central arch and conceals the low sloped gable roof beyond. The paired brackets at the cornice are typical of the Italianate style.*

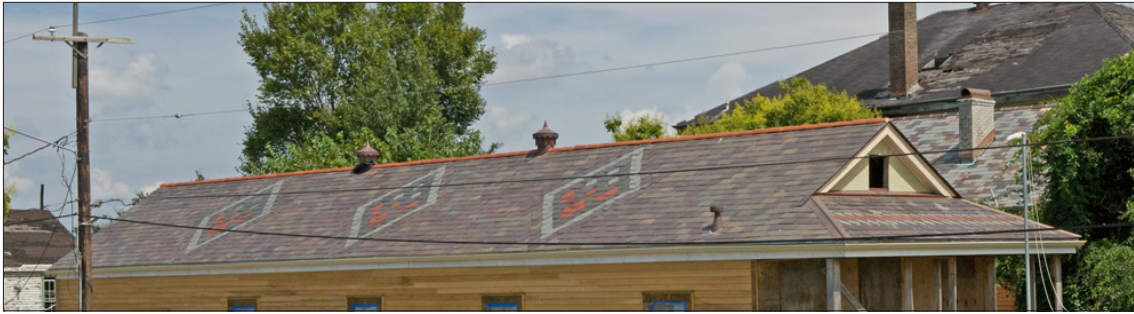
*This distinctive slate roof with diamond patterns, terra cotta ridge caps, and Chinese caps are being retained as part of the rehabilitation project.*

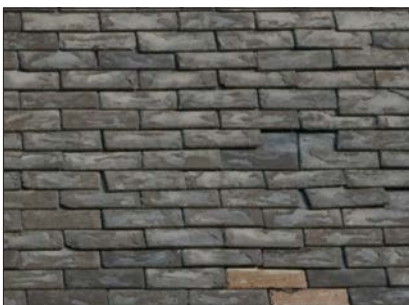
*Individual missing or damaged slates can often be replaced, extending the serviceable life of the roof and postponing costly replacement.*

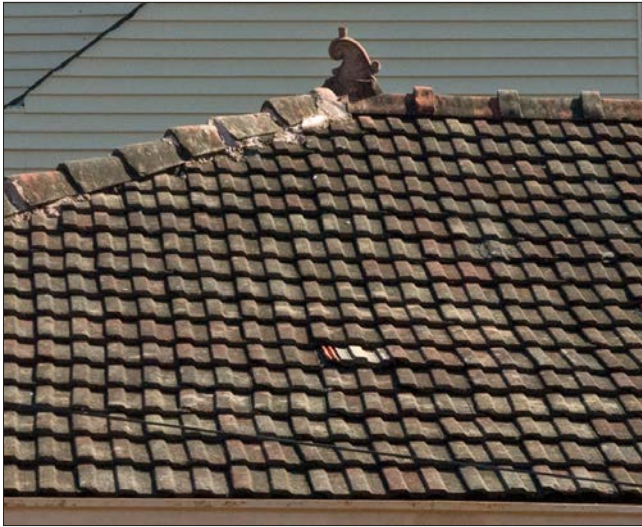
*This concrete tile roof includes a finial and terra cotta ridge caps at the top of the main roof and along the roof hip.*

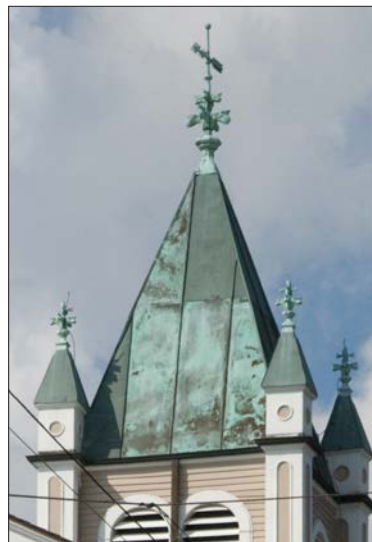
*The top of this church tower includes a standing seam copper roof, copper finials and a weathervane. Copper roofing is known for its longevity with relatively little required maintenance.*

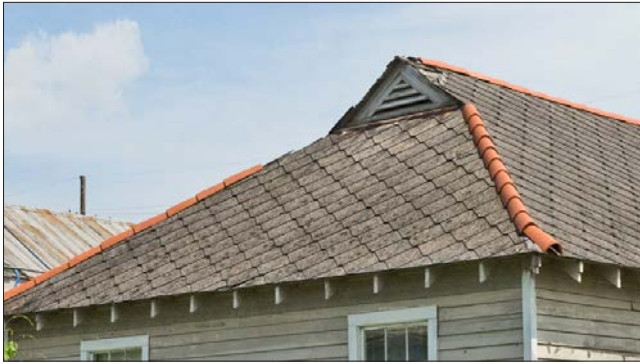
The asbestos shingle roof has terra cotta caps on the ridge and hips and a triangular louvered vent at the front gable. The ridge caps and louvered vents should be retained. Gutter installation is recommended.

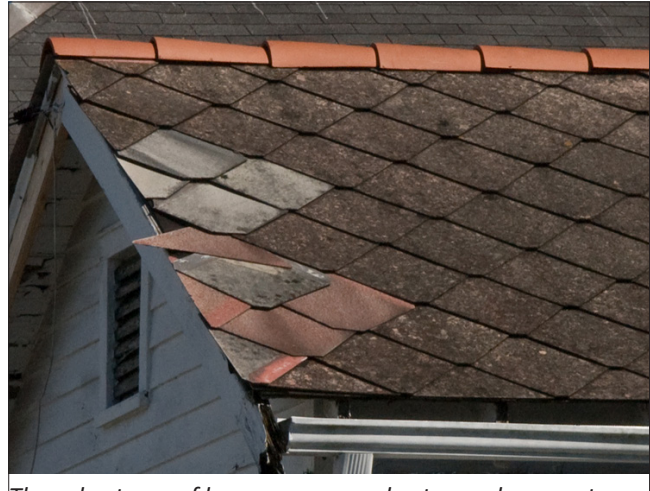
The asbestos roof has some non-asbestos replacement shingles of a similar size and shape as the existing roofing.

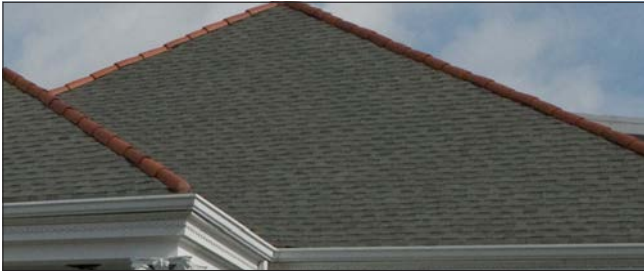
*This dimensional asphalt shingle hipped roof features ridge tiles at the hips and a perimeter gutter.*

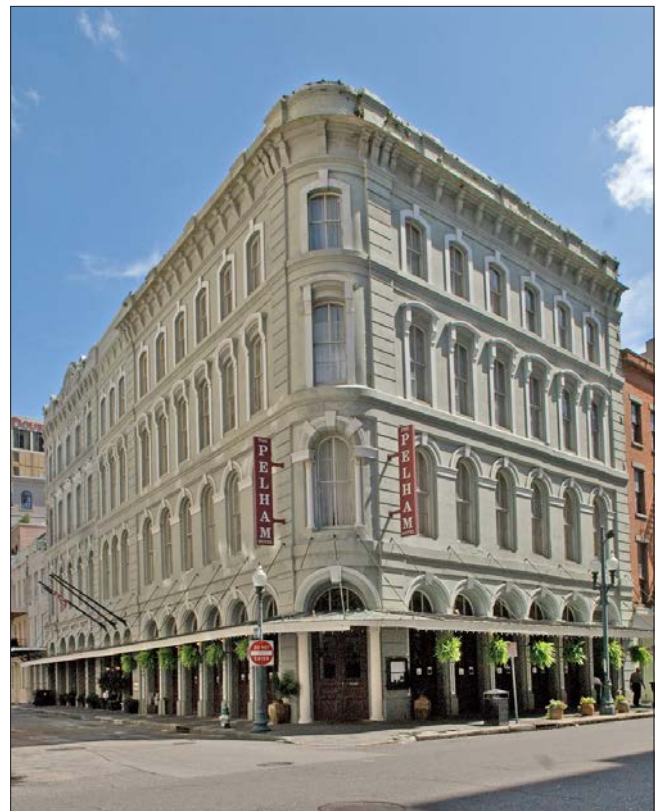
*A flat or low-sloped roof is located behind the parapet and bracketed cornice.*

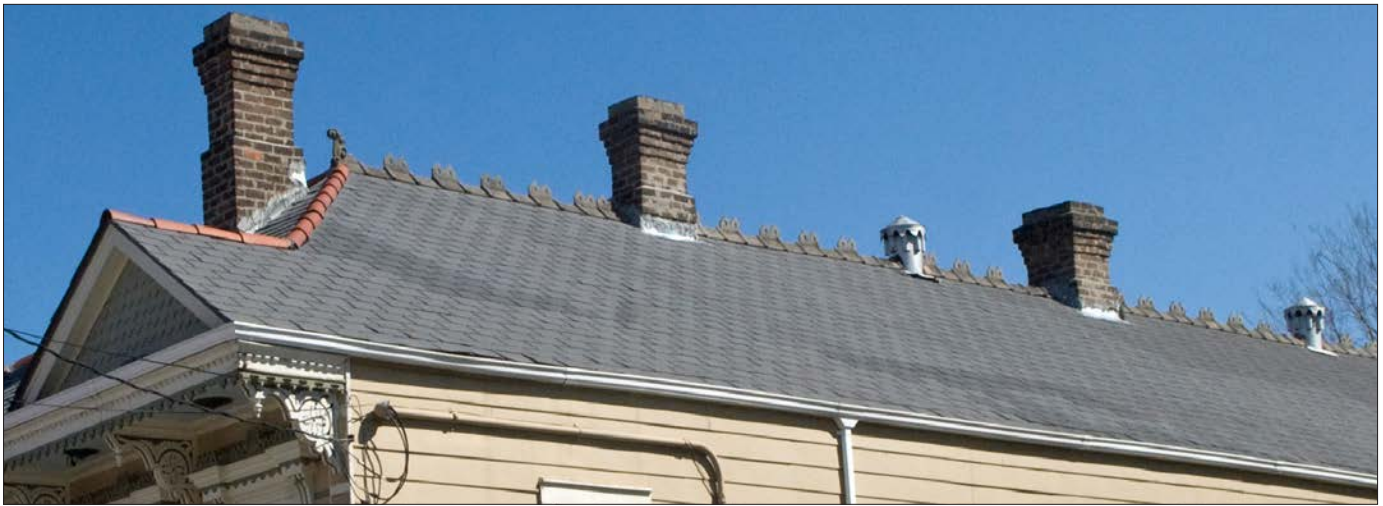
Ridge caps are located along the roof hips, cresting is along the top ridge and a finial is found at the end of the main roof gable. Chimney placement reflects the internal organization of the residence and Chinese caps provide roof ventilation.

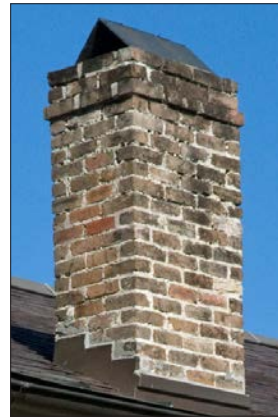
*An inverted "V" cap is at the top of the chimney and flashing at its base.*

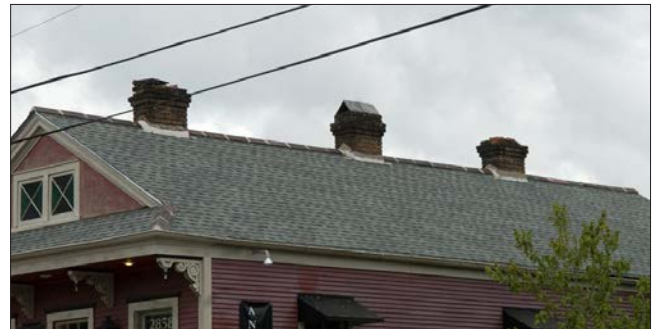
*This row of three chimneys suggests the division of rooms on the interior of the building. The central chimney includes an inverted "V" cap and English V ridge tiles with mortared joints marking the top of the roof.*

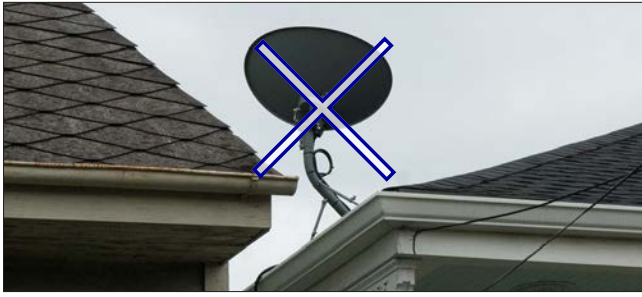
Satellite dishes should be installed towards the rear of the building so they are minimally visible from the street.

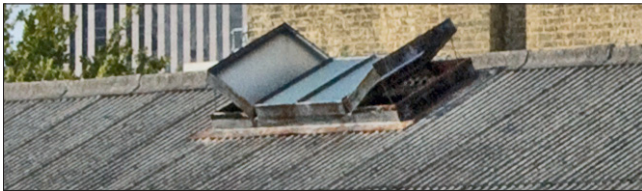
Some skylights were historically located in warehouse and commercial buildings, providing natural interior light and ventilation. The visibility of new skylights should be minimized.

**Skylights** are sometimes historically found in commercial buildings. They are occasionally appropriate in sloped roof building types and townhouses where dormer windows are not present. **Property owners are encouraged to select skylights that do not extend more than 8" above the roof surface; minimize the overall number; locate skylights a minimum of 10'-0" back from the front building wall, and 12" below the roof ridge, in unobtrusive locations, arranged in an orderly fashion.** The installation should minimize alteration of the roof structure with the long dimension oriented down the roof slope.

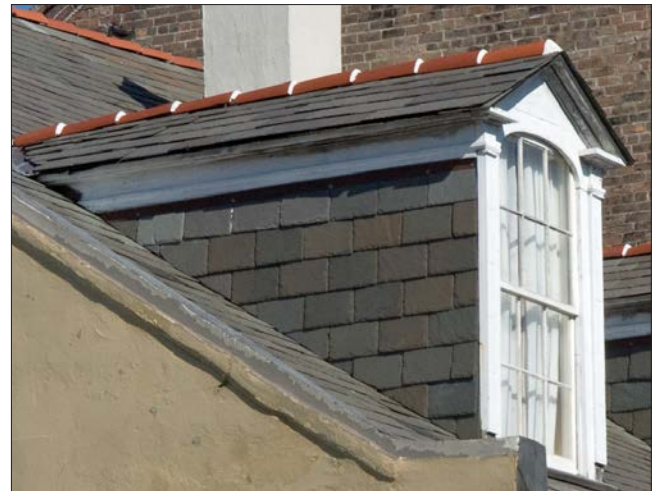
*This gable roof dormer is appropriately located, proportioned and detailed for the building and include slate cheek walls. Spanish tile ridge caps should be retained.*

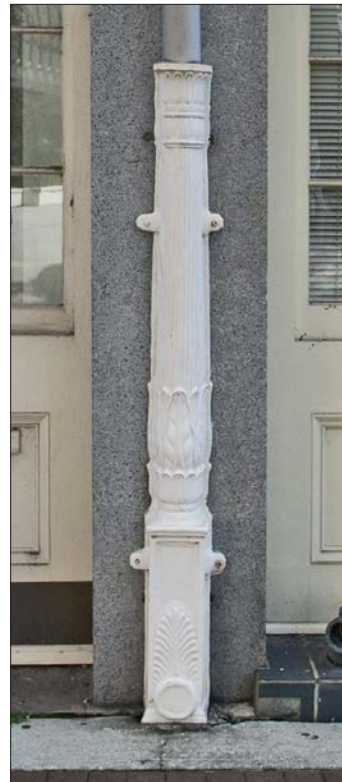
Decorative cast iron boots should be retained.
